CIA IMAGERY ANALYSIS DIVISION

## NORTH VIETNAMESE PORTS

The following study is a current assessment of North Vietnamese ports, utilizing previously published reports as a basis for updating. Included here are changes which have occurred as a result of bombing raids, as well as new construction and deliberate razing. Changes noted are depicted on the photographic enlargements of the ports. The following legend was utilized for annotating the changes:

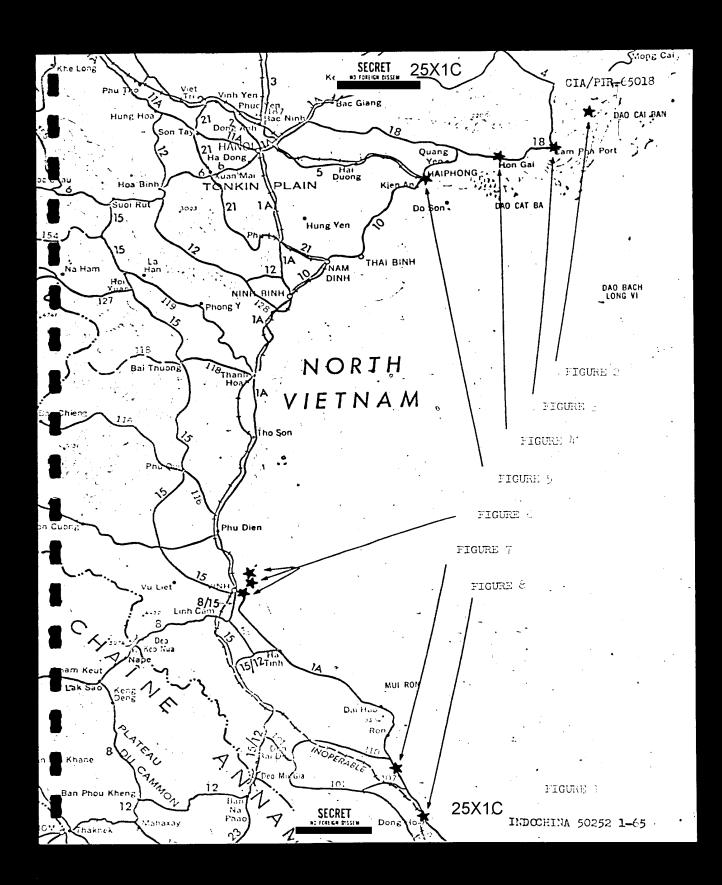
Comments - The previously reported side-haul marine railway has been completed and approximately 10 repairways have been constructed adjacent to it. Four new miscellaneous support buildings have been constructed west of the main port area. A new pier has been constructed in the inlet west of the main port area. The floating dry dock previously located near the side-haul marine railway has been relocated in this inlet. (Date of information

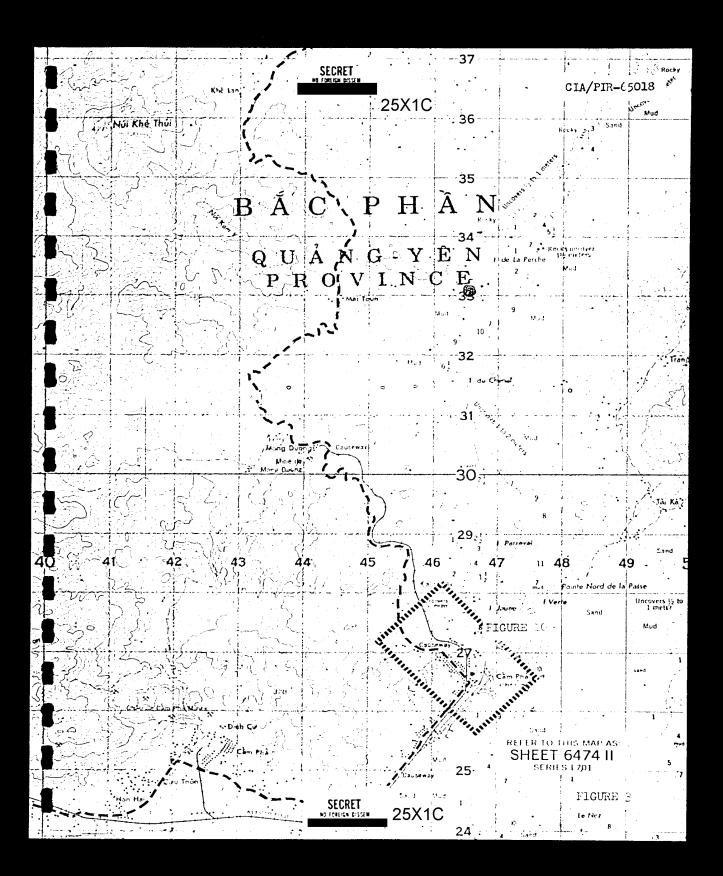
Comments The changes which have occurred since the previous report are the completion of the fifth barracks-type building, the razing of one building on the shore line, and the construction

of a sea wall.

Of interest is the almost total absence of barges and small craft. (Date of information

- D. Bai Chay 20 57N 107 04E References - CIA/PID Project No. 30073-5, dated 28 January 1965 Map - Figure 4 Photograph - Figure 12
  - Comments The construction of five new buildings has been completed, and one building has been razed. New sea walls have been constructed along the shore line, indicating possible future expansion. (Date of information
